# Small scale and large scale monitoring of vegetation changes in a restored wetland

**“W3M Conference For Wetlands: Monitoring,  
Modelling and Management”  
22-25 September 2005**

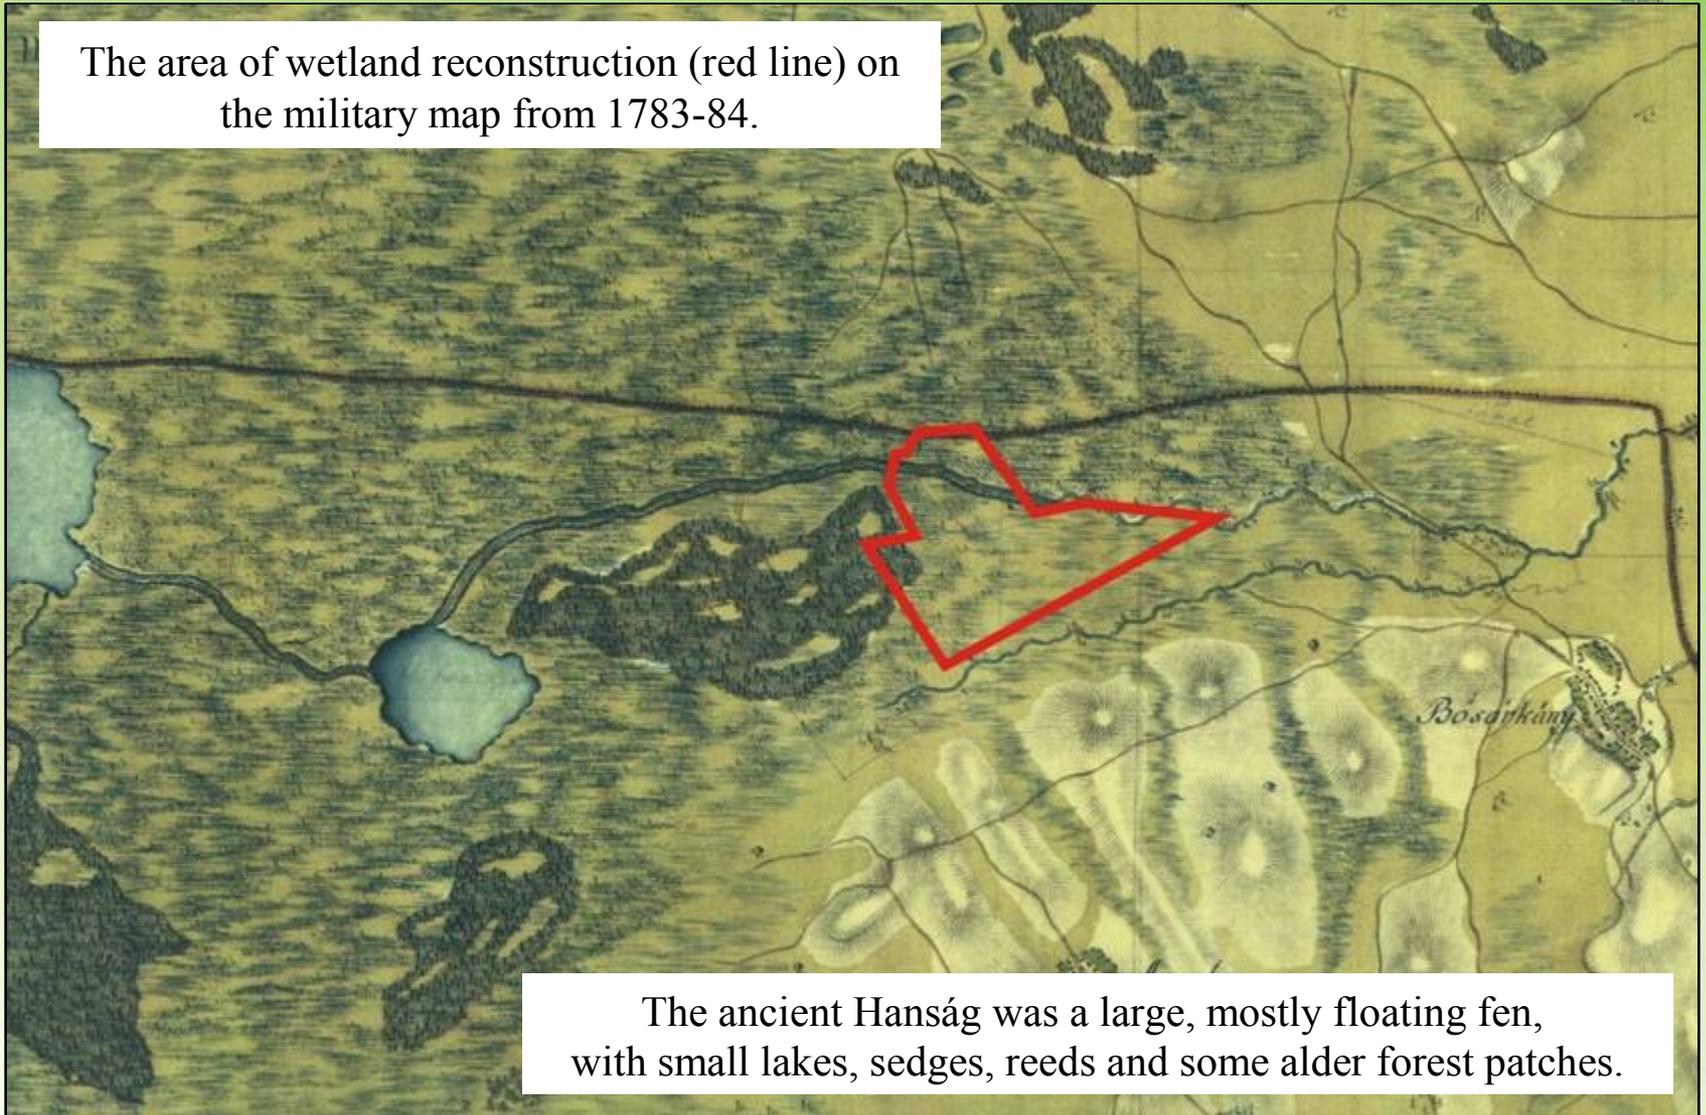
The area of wetland reconstruction (red line) on the military map from 1783-84.

The ancient Hanság was a large, mostly floating fen, with small lakes, sedges, reeds and some alder forest patches.

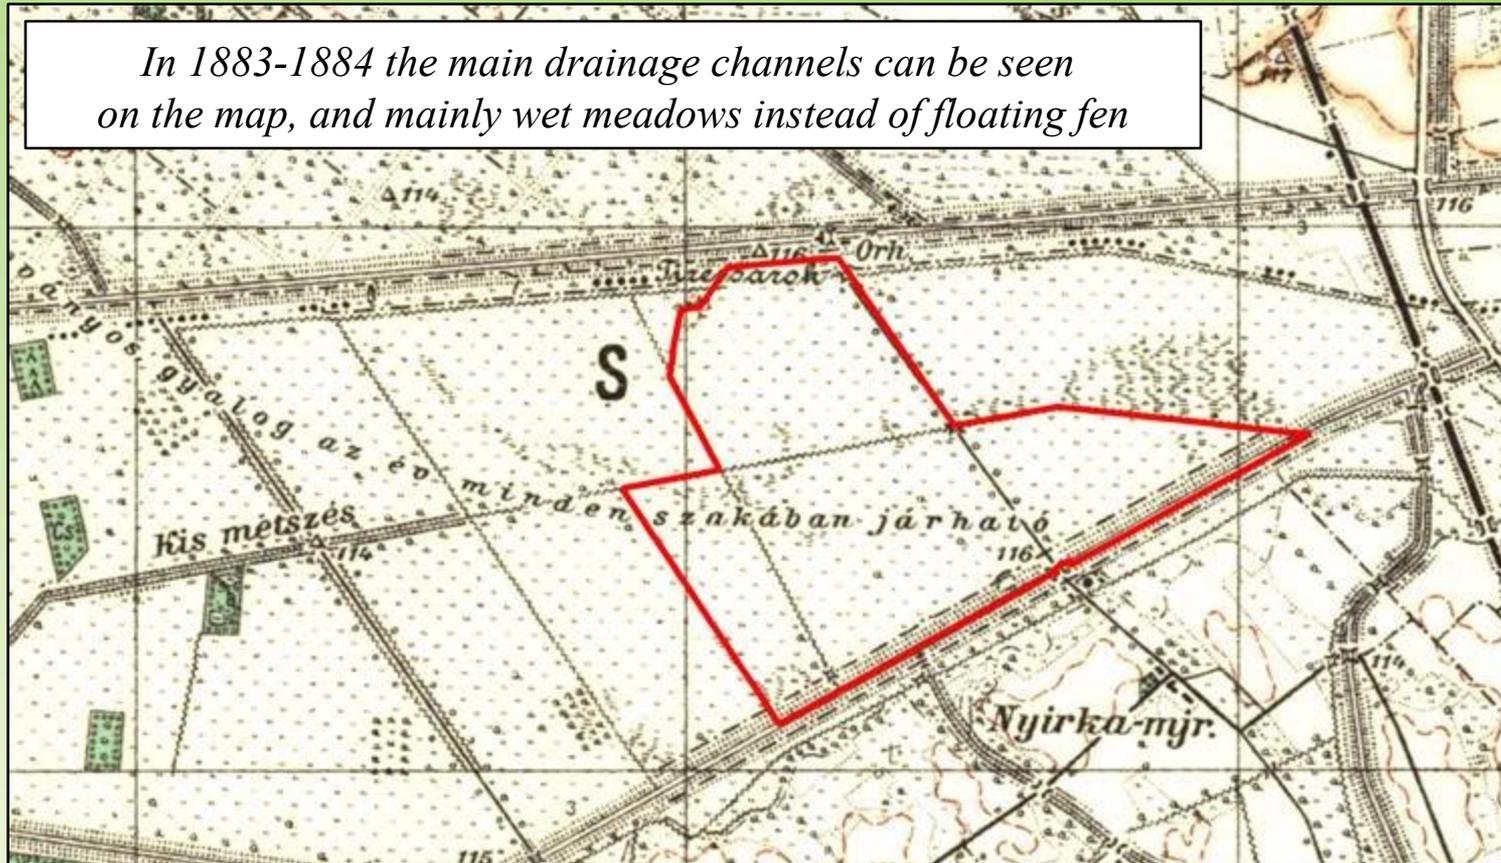
*In 1883-1884 the main drainage channels can be seen on the map, and mainly wet meadows instead of floating fen*

The drastic drying-out of the fen was „successful” only in the early 20th century, using machines to dig channels. Secondary meadows formed in the place of the fen, and most of the lakes disappeared. A large part of the area was ploughed, afforested, and peat mines were opened.

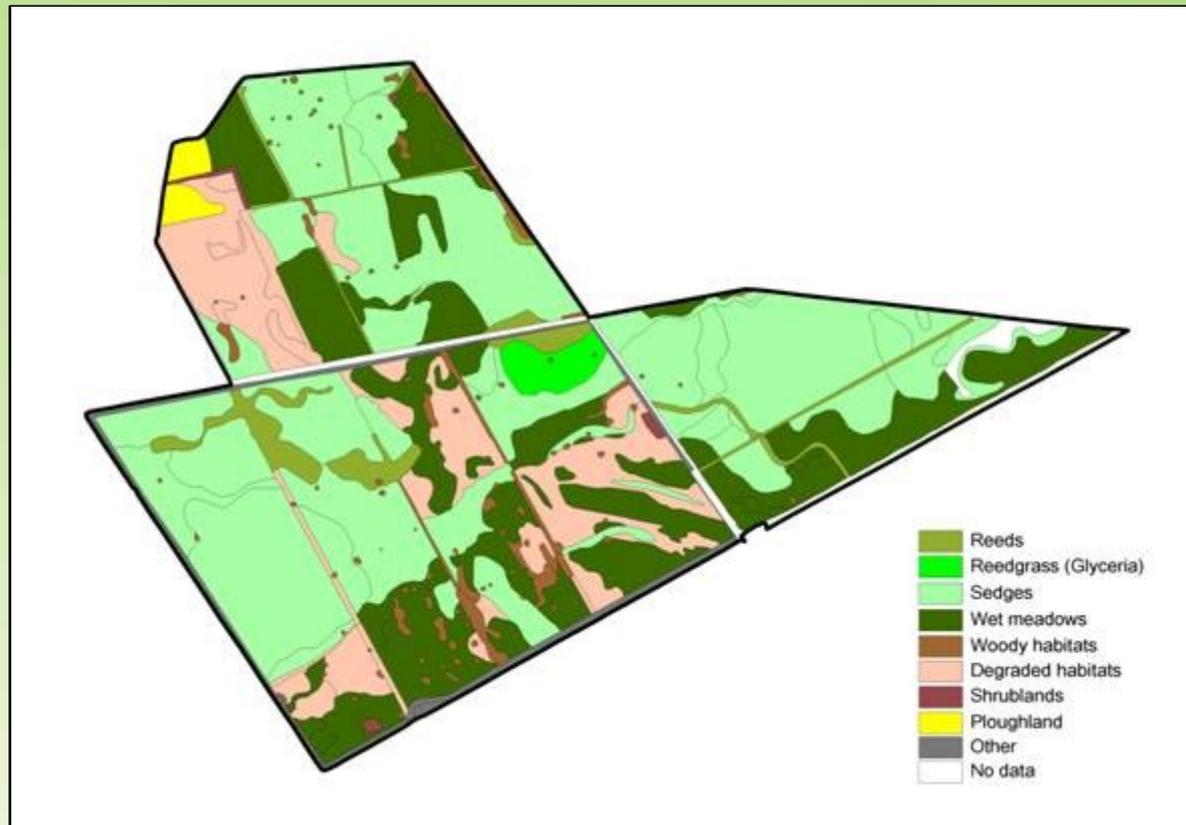
## A habitat map were made before flooding

**Large sedges (57%)** (*Carex riparia*, *C. acutiformis*), and **wet meadows (28%)** (*Alopecurus pratensis*, *Festuca arundinacea*) were the dominant vegetation types and some **reeds (5%)** (*Phragmites australis*, *Glyceria maxima*) also occurred.

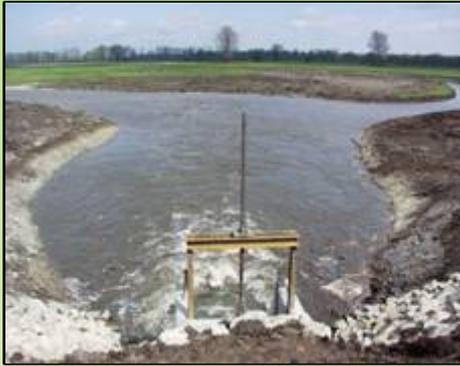
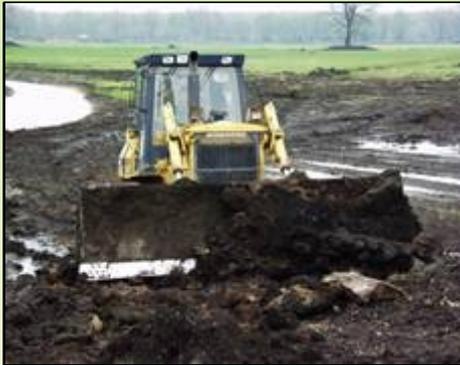
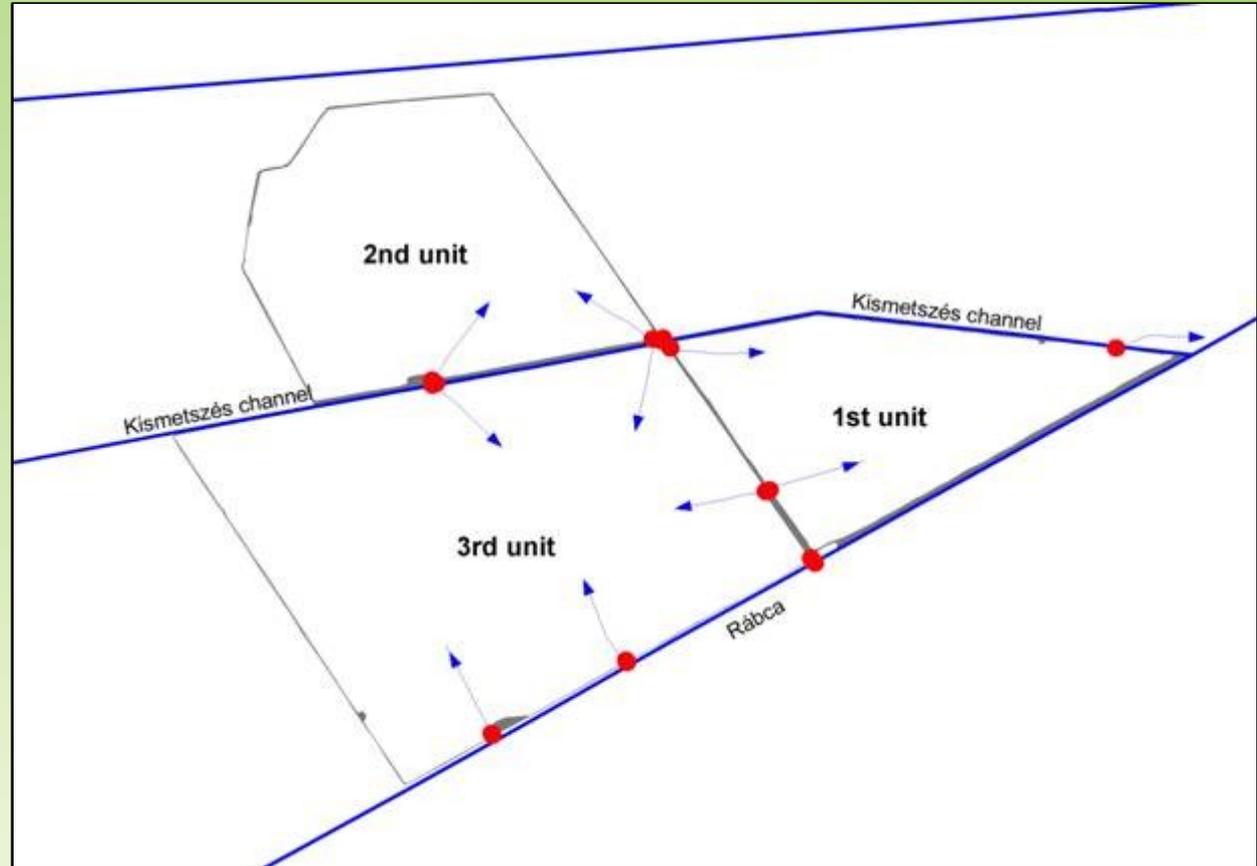
## Technical aspects of reconstruction

Dikes were built around the planned wetland pools (if needed), and water was transported by gravitation through sluices from the river Rábca and the channel Kismetszés. The 1st and 2nd unit was flooded in spring 2001, and the 3rd unit in autumn.

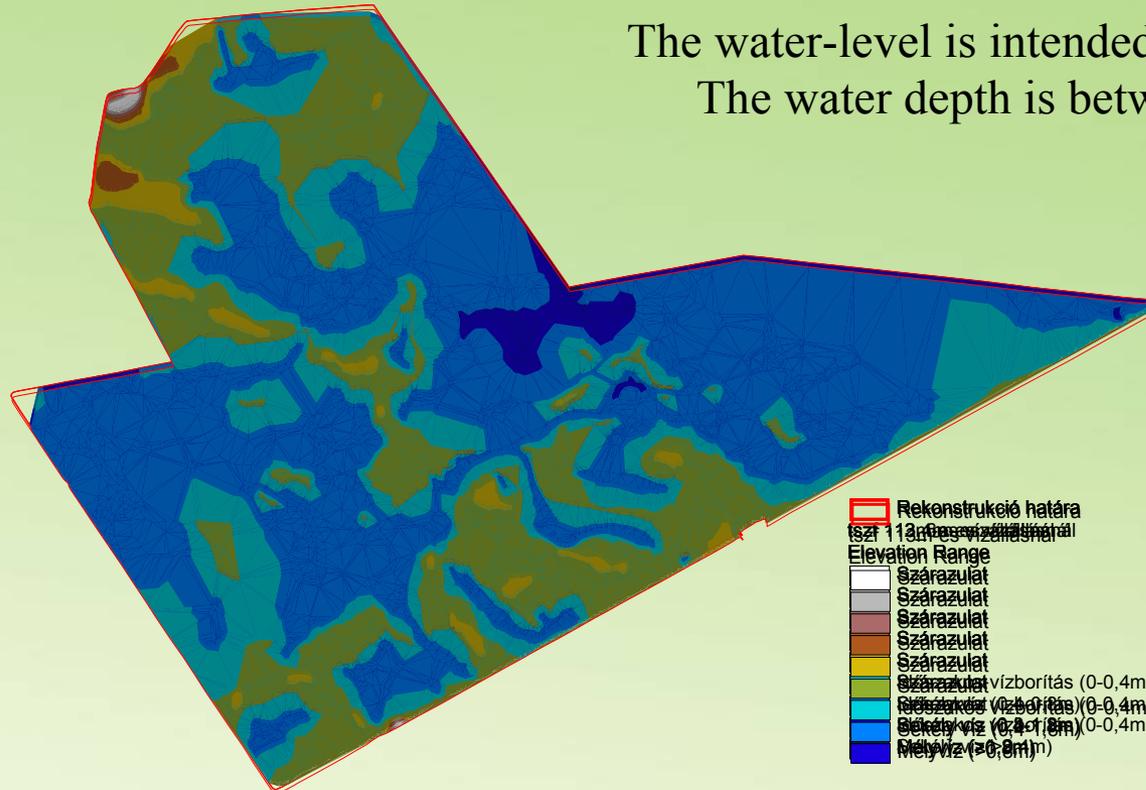
# The water-level

The water-level is intended to keep constant.  
The water depth is between 0-100 cm.

The average water level is 113m above the sea

The year 2001 and 2003 was very dry, so the water level was about 20 cm lower.

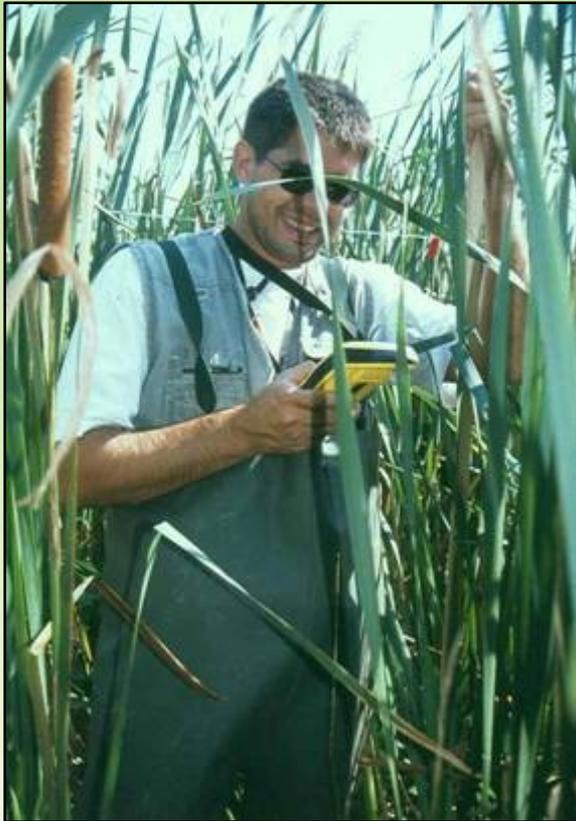
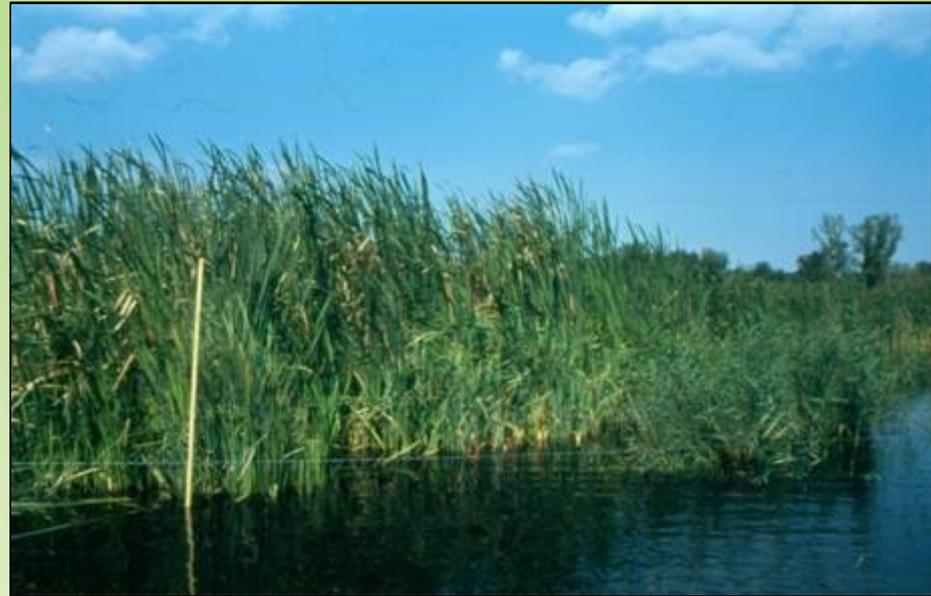
## Small scale monitoring method: permanent transects

The end of the transects were marked by wooden sticks, and positioned using GPS.

The percent cover of plant species were recorded in 20 pieces of 5x5 m quadrates along each transect.

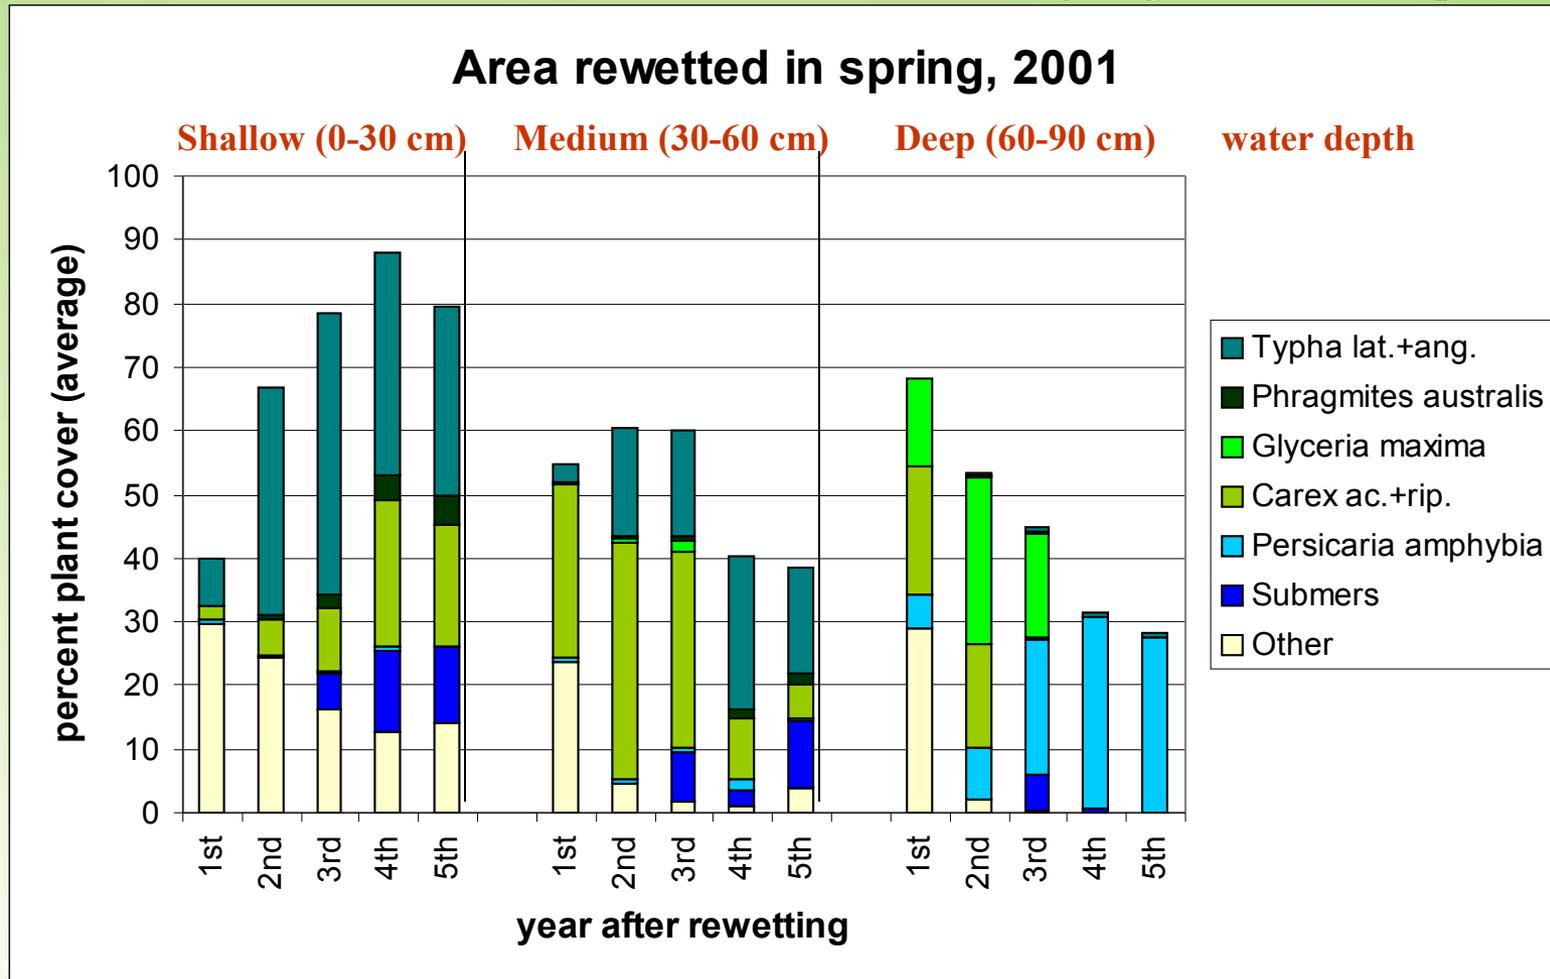
## Result of small scale monitoring

Water is one of the main environmental factor affecting vegetation development.

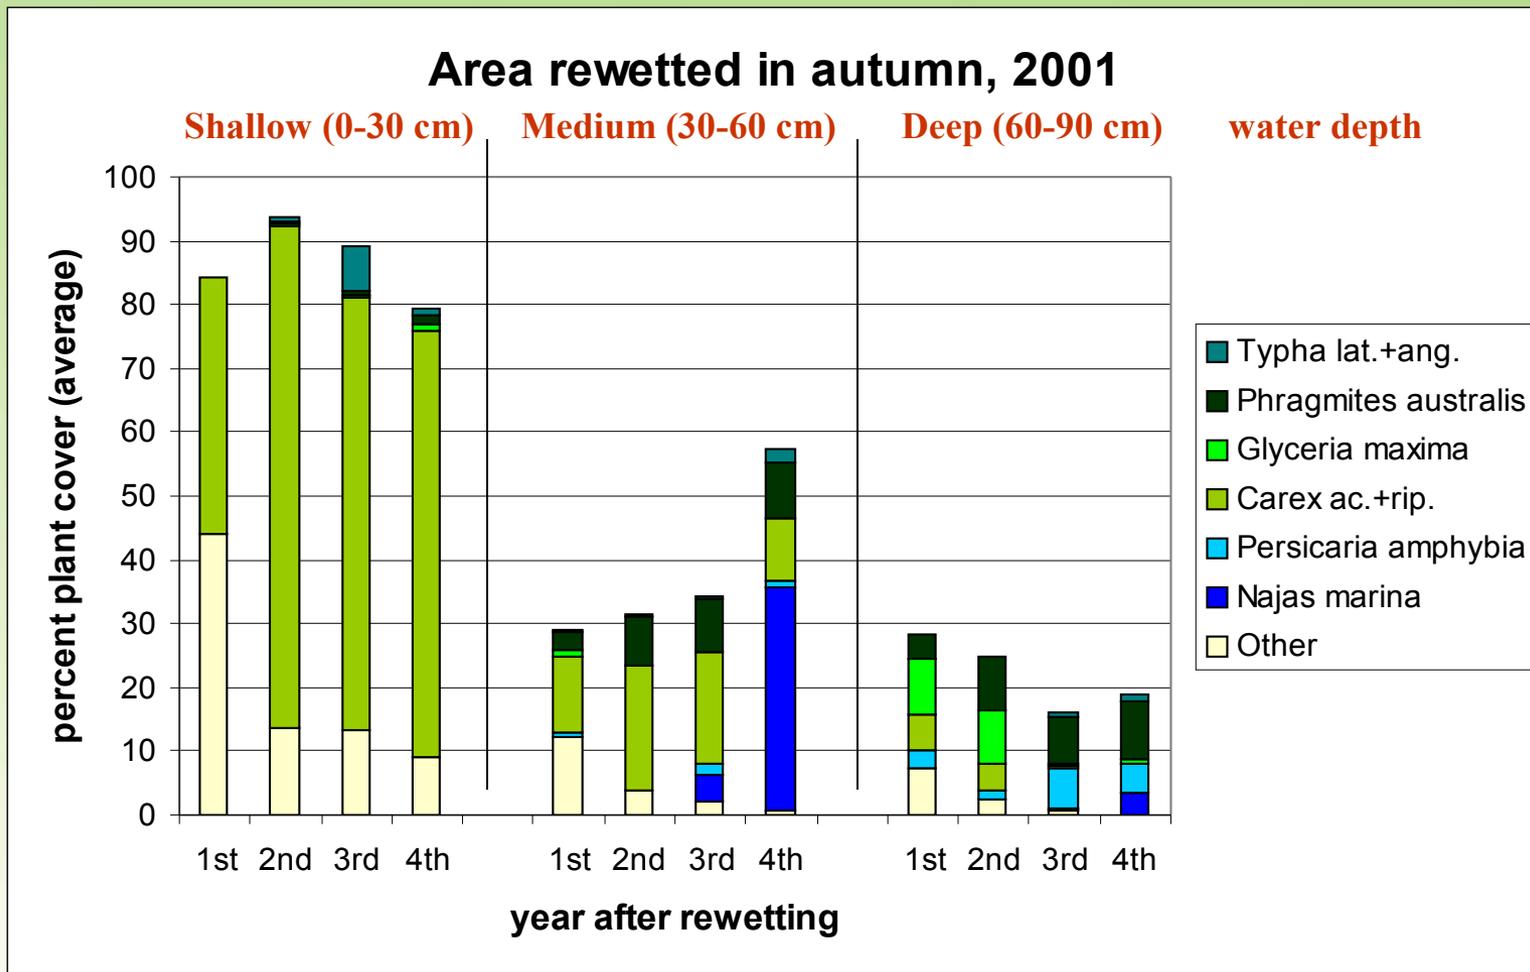
## Result of small scale monitoring

Water is one of the main environmental factor affecting vegetation development.

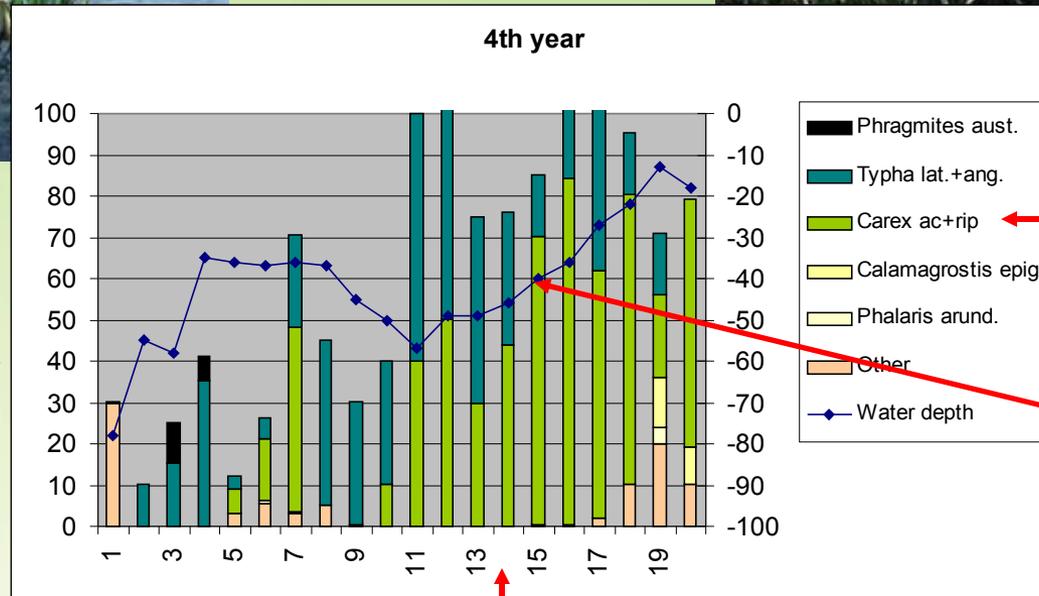
Percent cover of species

Species,

Water depth

Sequence of individual relevés in the transect

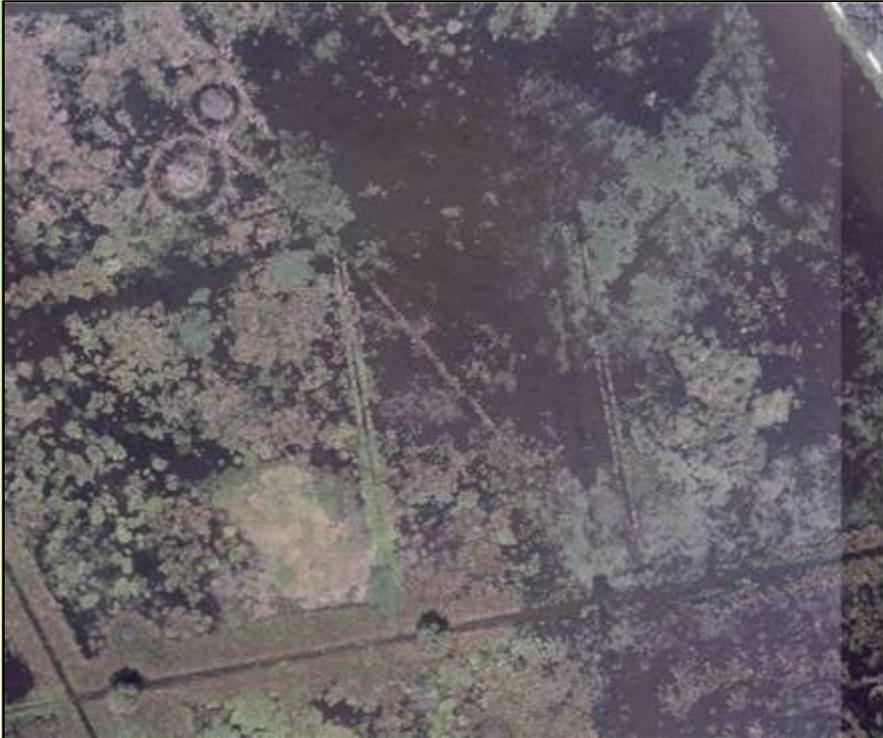
## Parameters of the aerial photograph:

- Service: Telecopter Kft.
- Date of flight: 2003.07.15. (12:00 – 12:15)
- Film material: K color III 2444
- Flying height: 1200m
- Camera: Wild RC-10 (f=153,1mm)
- Overlap: 60%
- Resolution: 1 m

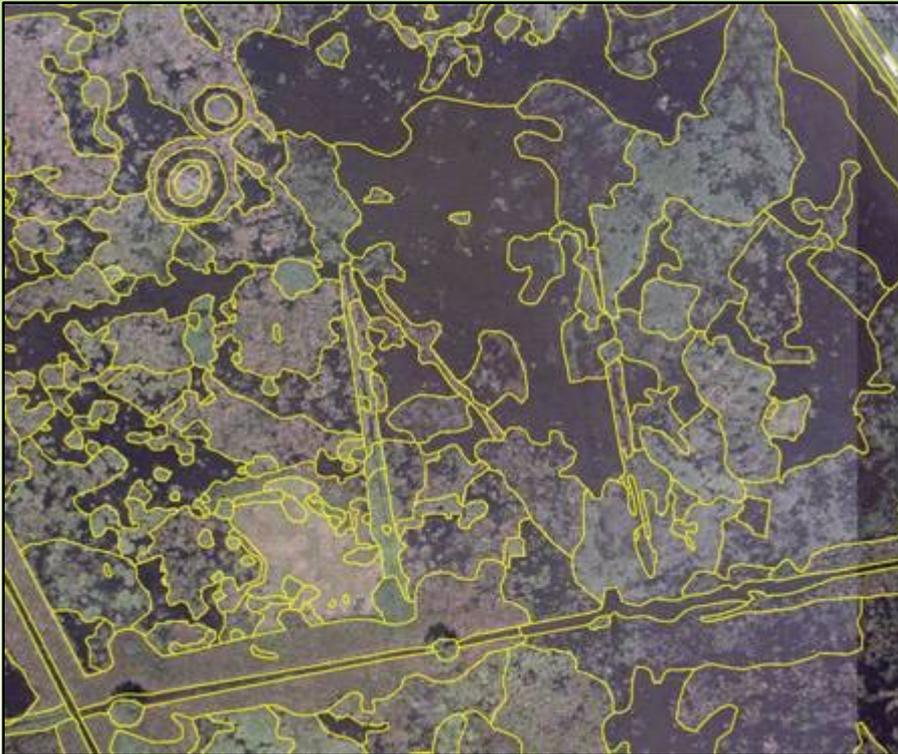
## Processing of the aerial photograph

- Scanning with 18 $\mu$ m resolution and 16 bit color depth. Ortorectification with field reference points by ERMAPPER 6.1 and DIGITERRA (Hungary) softwares.
- Outline of the possible patch contours in the computer (manual).

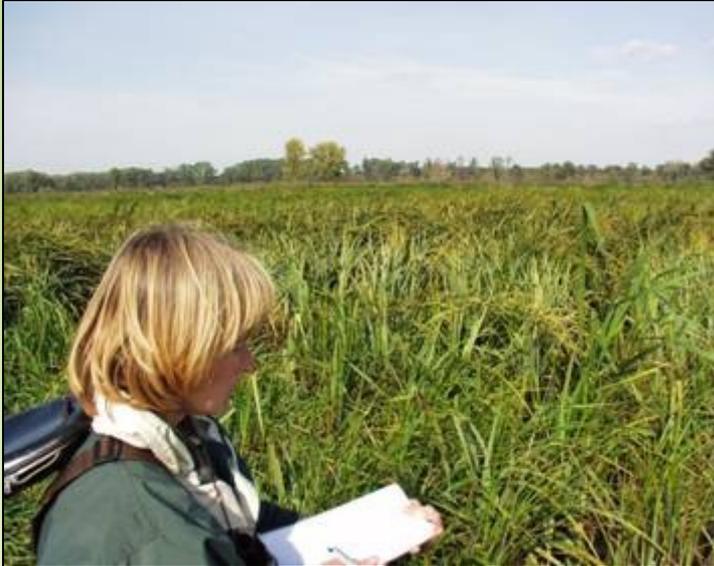
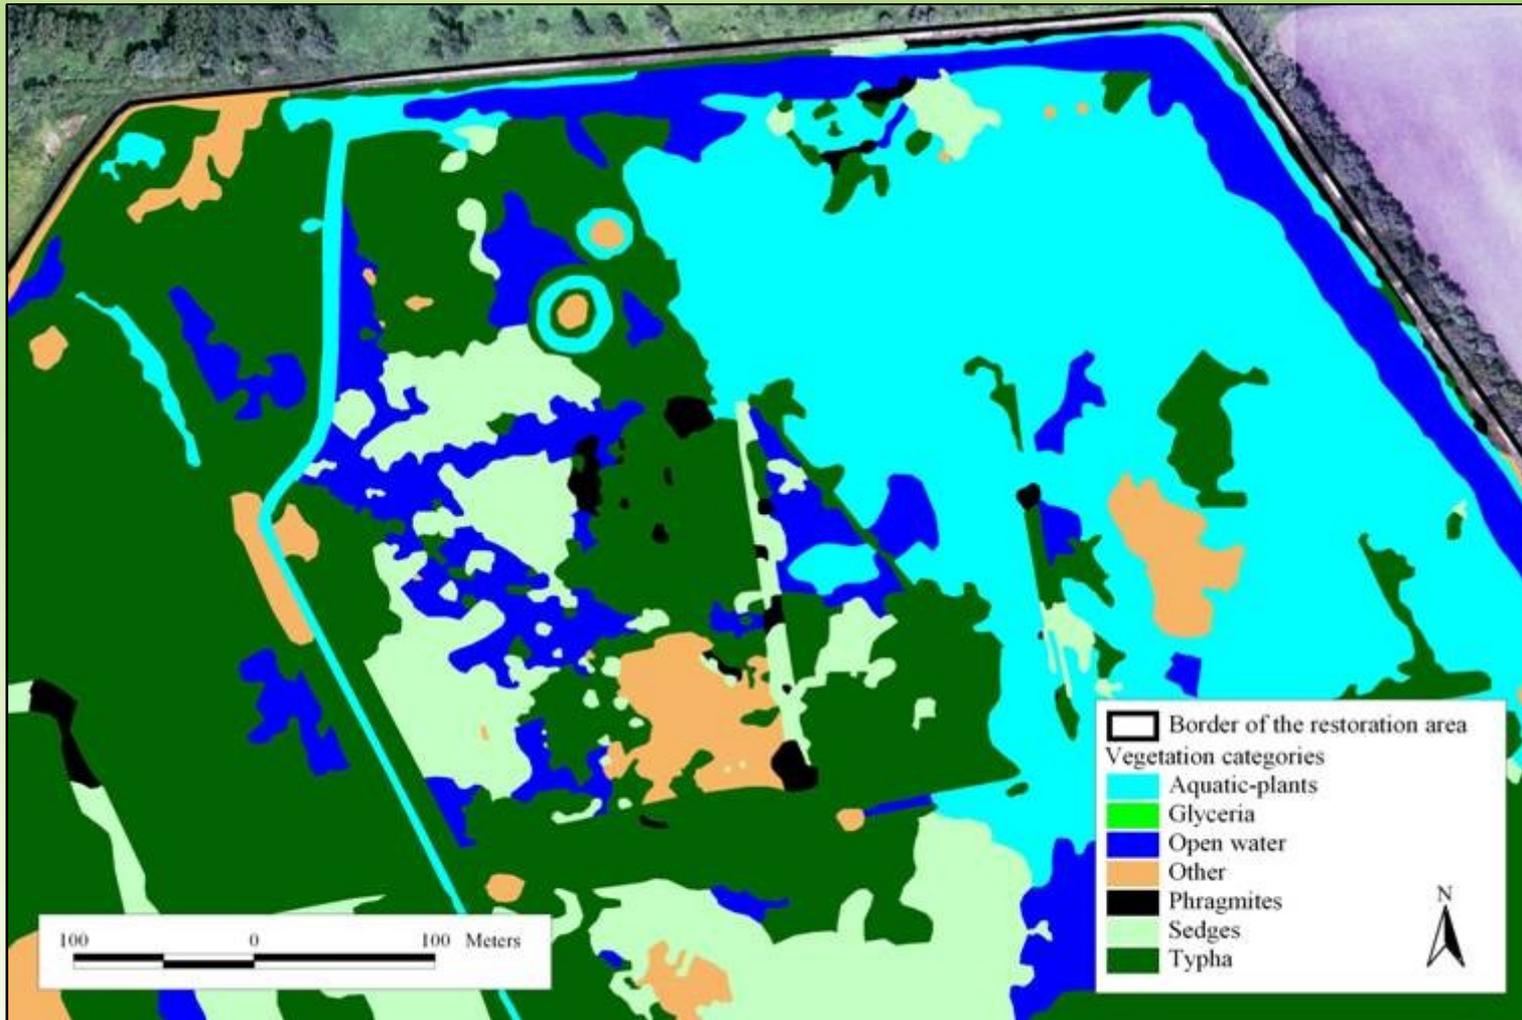
## Field work

- Identification and correction in the field. (vegetation category, main species and their cover, total vegetation cover)
- Build GIS database from the data
- Data processing by raster analysis (One pixel is 1x1 m)
- GRID statistics

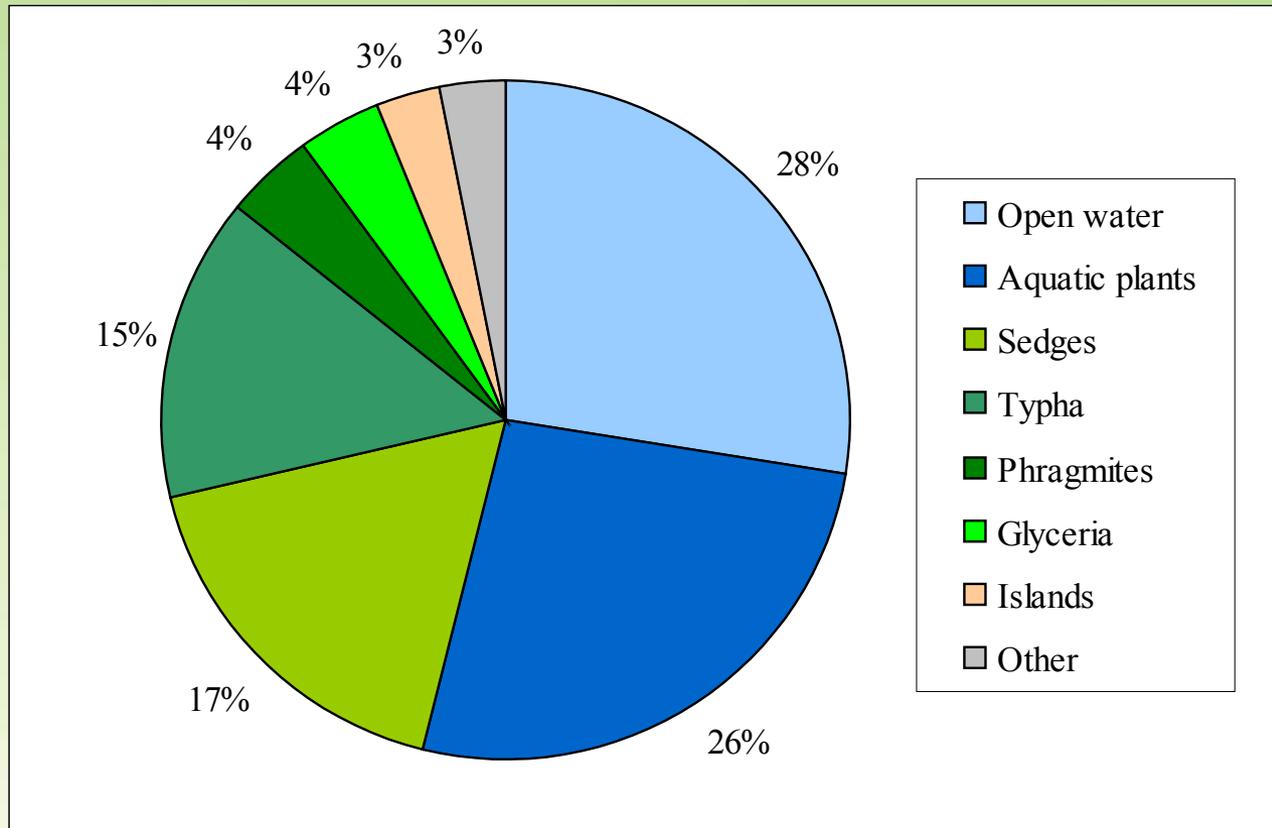
## Grid statistics

Area (in percentage) of vegetation categories in the whole restored area in 2003.

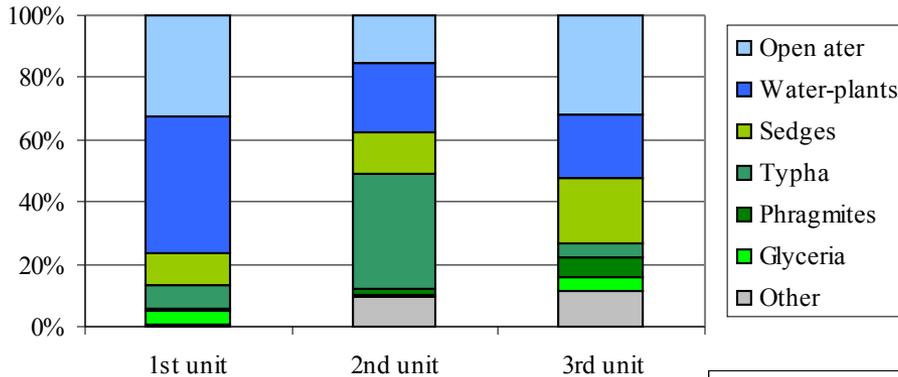
Vegetation map (2003)

**Glyceria is overrepresented**

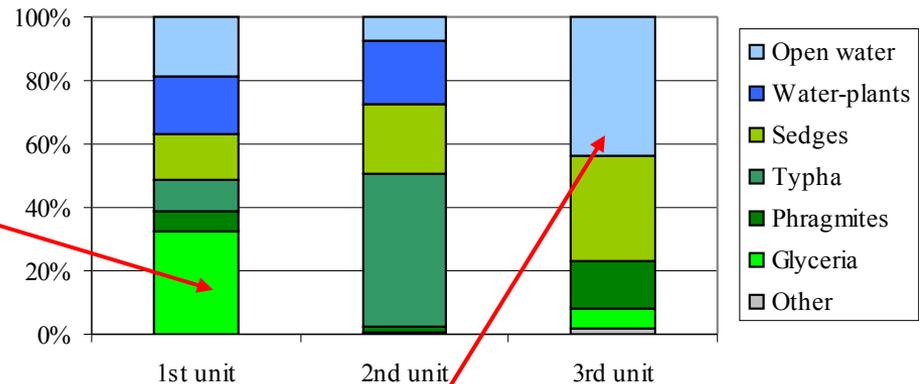
Transects (2003)

**Water plants are underrepresented**
