Phosphate Mine Reclamation in Tennessee

E. J. Griffith and H. N. Lyles¹

Griffith, E.J. and Lyles, H.N. 1996. Phosphate Mine Reclamation in Tennessee. In: Landis, T.D.; South, D.B., tech. coords. National Proceedings, Forest and Conservation Nursery Associations. Gen. Tech. Rep. PNW-GTR-389. Portland, OR: U.S. Department of Agriculture, Forest Service, Pacific Northwest Research Station: 59-68. Available at: <http://www.fcnet.org/proceedings/1996/griffith.pdf>

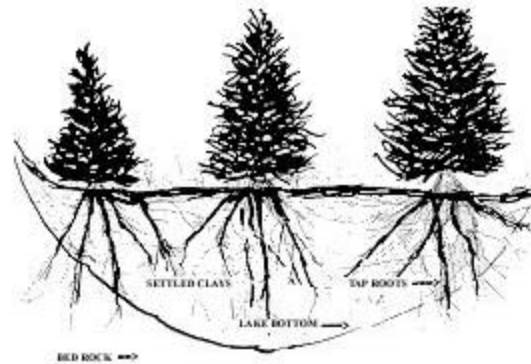
FIGURE 2.

It can be seen in Figure 2. how the tap roots of large cypress trees can not only stabilize the pond solids but also eliminate the sandwiching behavior of the settling clays. This occurs because the trees remove water by respirating it from the dilute slurry between the crust and the settled clays as it attempts to form. In the case of No. 15 Pond the planting of the trees began before the crust ever had a chance to dry to any depth. The trees should prevent the dilute slurry from ever forming in the pond while the trees can drop a tap root quickly through the soft uniform clays below.

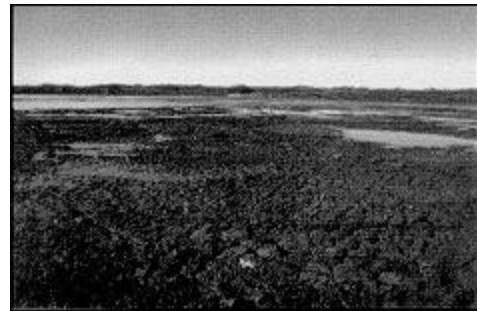
No. 15 Pond was first drained in 1989. Other ponds had been drained much earlier. Figures 3 shows the results of draining No. 15 Pond. It is also worth noting the nature of the clay as is freezes and thaws and dries. Judging from past experience, the concentration of the top lumps are about 30% solids or less. This is another example of the contraction of the clay as water is removed. It points up how much of the volume of an abandoned pond is occupied by water. Figures 4 and 5 show Ponds 15 and 12 before they were drained.

Figure 3. The behavior of drying clays in No. 15 Pond to prepare it for planting.

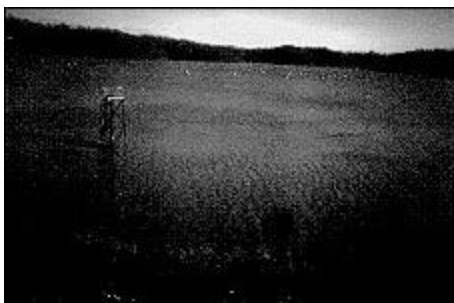
Figure 4. No. 15 Pond as an active mountain lake.

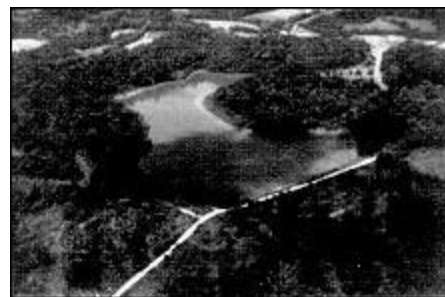
Figure 5. No 12 Pond as an active pond.

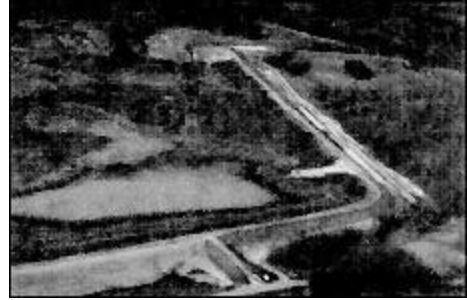
Figure 6 shows No.7 Pond after it was drained to plant trees in the lower end of the pond. Unfortunately the drain pipe for this pond collapsed when the pond was first filled and the drain was grouted closed with concrete. The original drain pipe can be seen as a light colored spot at the end of a short road on the far right side of the picture. This is a road leads from the road on top of the dam. The collapse of the drainage pipe required the construction of a deep drainage ditch to rid the pond of most of its water. This ditch can be seen as a straight line leading from the water's edge to near the top of the picture forming a "V" with the light colored road on top of the dam.

Figure 6. No. 7 Pond when it was drained for tree planting experiments. (Note: The large trees to be discussed later were planted on the drained part of No. 7 Pond far to the left of the picture.

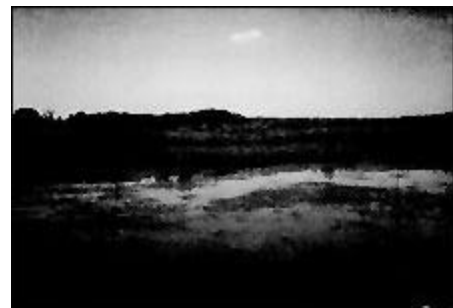
Figure 7 shows trees planted in No.9 Pond. No.9 Pond is very small and shallow. Trees have grown well in this pond even though many were planted in water and remained in water. The progress of the growth can easily be seen in Figure 8 which is three years growth of the trees from Figure 7. Note the hill in the background for reference.

Figure 7. No. 9 Pond in the early days of planting in May 1992.

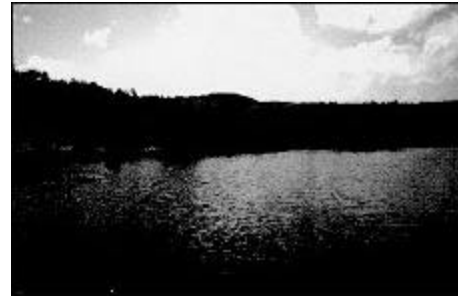
Figure 8 is almost the same picture of No.9 Pond as was Figure 7. Figure 8 vividly demonstrates what only three years growth can bring to the cypress tree sizes. The trees are performing splendidly. It is expected that the shallow water in No.9 Pond will eventually be replaced with silt and that the cypress trees will seed new growth themselves. At this time there seems to be no need to either plant more trees or to thin those that are currently growing. The process should take care of itself leaving a grove of cypress trees with perhaps a small stream through it for a few years. All water to this pond is run off from the surrounding land.

Figure 8. No. 9 Pond in May of 1995 three years after the picture shown in Figure 7.

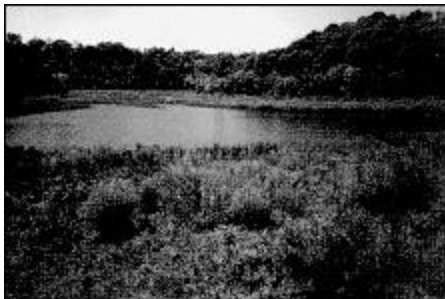
Figures 9 and 10 compare the growth of trees on No. 12 Pond during the period from May, 1992 through May, 1995. Again the growth has been spectacular. No. 12 Pond also faced a drainage problem. In this case the top water flume could not easily be lowered. A new drainage system was cut through the stones to the left of this picture. The hydrolytic loading of the dam should be diminishing as the trees grow larger and stabilize and dehydrate the waterlogged soils below.

Figure 9. No. 12 Pond in early 1992. Note the small trees at the water's edge and use the hills for reference in the next picture.

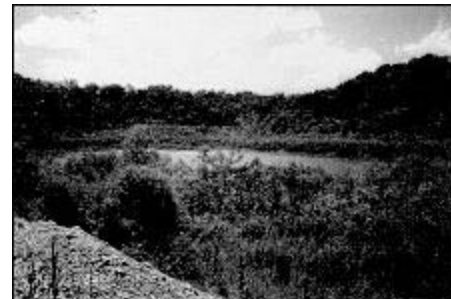
Figure 10. No. 12 Pond in May 1995 showing three years of growth from Figure 9.

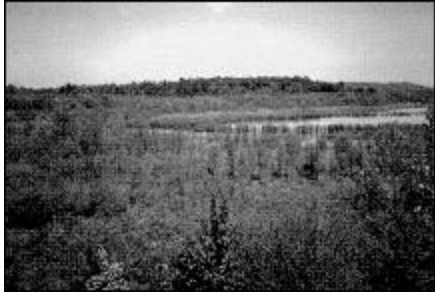
Figures 11 and 12 show the growth of trees on the wet end of No.7 Pond. Tree growth on this pond has far exceeded expectations and is a picture perfect example of what was desired. There was never great concern for stabilizing the soil in this pond for dam protection. There was the concern to dry up the waterlogged slimes in the depths of the pond to prevent the danger of breaking through the dried crust of the pond. As mentioned earlier there was a drainage problem with No.7 Pond also, but it is believed that this problem has been satisfactorily solved. Additional planting as the system dries could be of benefit, but the trees should seed the new growth and silting in should be rapid in this location.

Figure 11. No. 7 Pond in 1992 showing the planting at the water's edge.

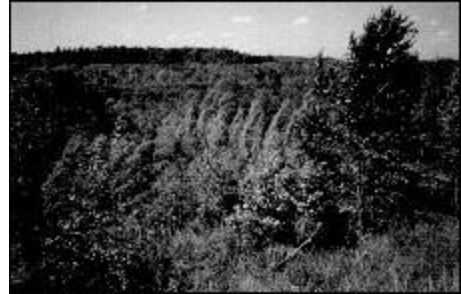
Figure 12. No. 7 Pond three years after figure 11. June 1995.

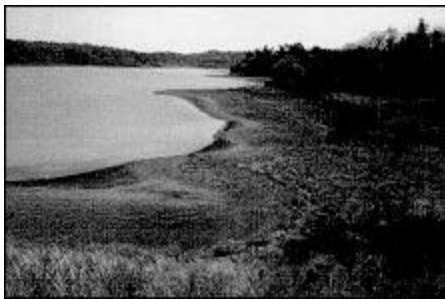
Figures 13 and 14 demonstrate the progress achieved with No. 15 Pond. The pond is much too large to give more than a very selected view. The size of the pond has shrunk dramatically since 1992 until 1995. Note the planting lines as the following years grow is smaller than the year before. The spacing is almost perfect. The water level on this pond has been controlled to keep down grasses that will choke light from young trees.

Figure 13. The view of No. 15 Pond in May, 1993. The photograph was made from the tower seen in Figure 15.

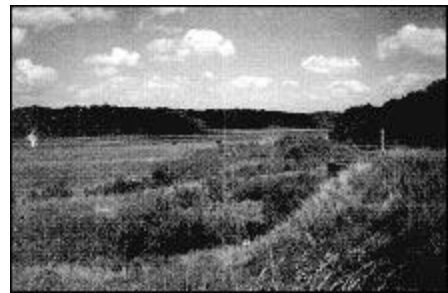
Figure 14. The view of No. 15 Pond in May, 1995. Note that all water in this part of the pond has been drained.

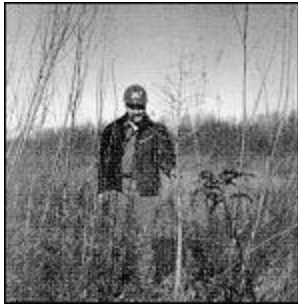
Figures 15 and 16 tell the story of Monsanto's Cypress Garden as well as any pictures can tell the story. Figure 15 is one of the test trees planted in a row across the back shallow side of No.7 Pond. To plant these trees the personnel doing the planting lay on big sheets of plywood and were pulled across the wet clay. By the time the picture was made of the tree in Figure 15 one could walk safely across the dried clay.

Figure 15. One of the test trees planted on No. 7 Pond in 1974. This is one of the same trees shown in Figure 16 twenty years later. (The late Joseph Green did much to support the early work with trees.)

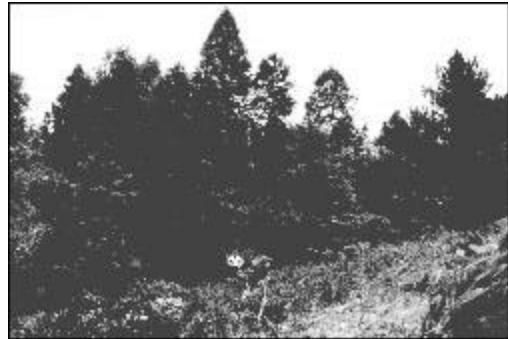
Figure 16.

Figure 16 shows the line of trees planted in 1974 after they have grown for twenty years. Very few if any of the trees were lost.
